**THE 25 MOST ENVIRONMENTALLY
DAMAGING DIRT ROADS
IN BALDWIN COUNTY**

**The Baldwin County
Environmental Advisory Board
December, 1998**

**THE 25 MOST ENVIRONMENTALLY DAMAGING
DIRT ROADS IN BALDWIN COUNTY**

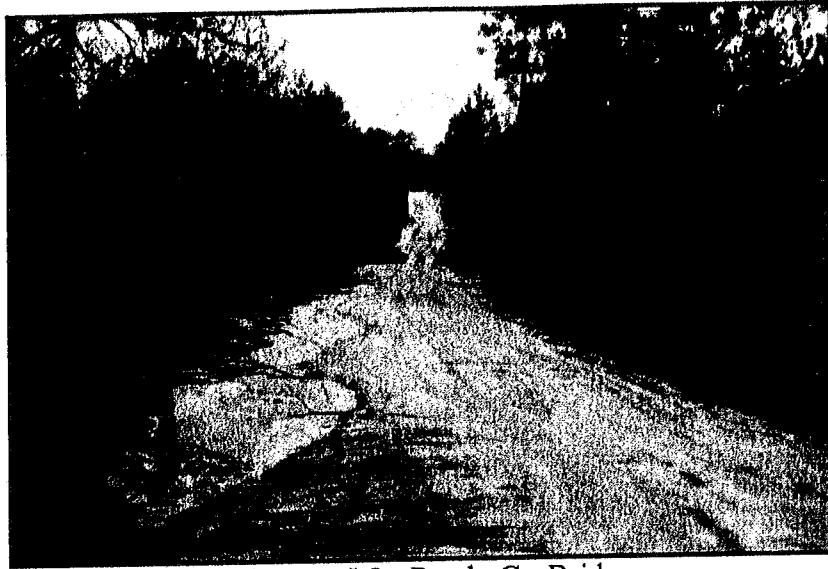
Mile Post 5.8 - Reedy Cr. Bridge

Same problem exists at the Reedy Creek Crossing as at previous sites. Nearly 1/2 mile of severe ditch erosion was noted. This material all moves directly to Reedy Cr. Also noted in this general area were a number of logging roads tributary to Truck Trail 17, and which direct drainage to it, thus compounding the erosion problem.

RECOMMENDED CORRECTION OR REPAIRS: In summary, nothing short of relocation and reconstruction will cure the problems associated with this road. Currently the alignment is straight and rolls over the terrain. Relocation on a contour will flatten the road and ditch grades as they approach stream crossings. Stabilizing the roadway will do little without equal attention being paid to the ditches.

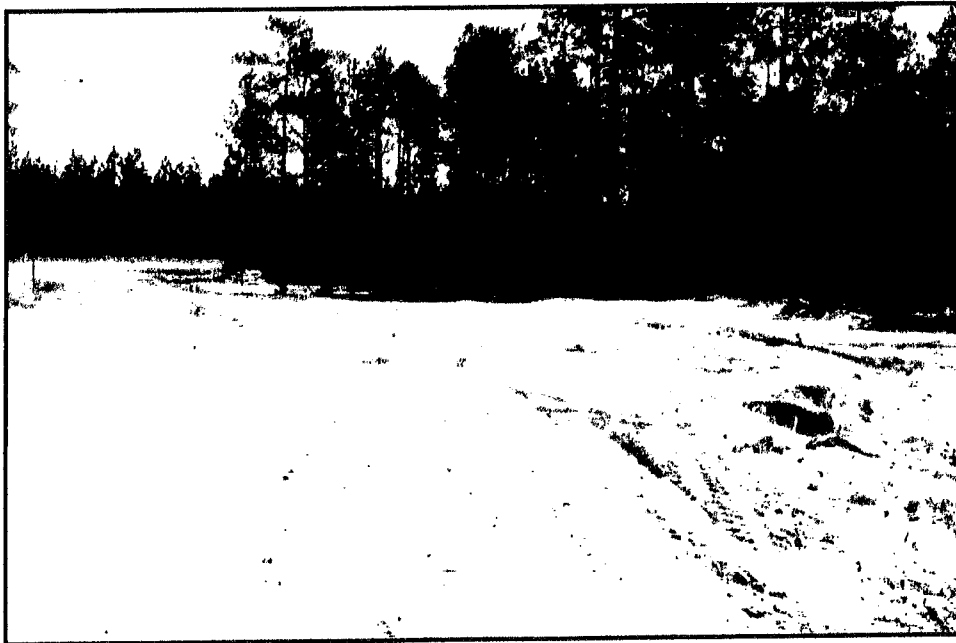
Mile Post 0.3 - Flat Creek

The road crosses Flat creek at Mile Post 0.3 and shows signs of frequent breaching. Several bridges at this location have washed out, and since have been replaced with a culvert. It appears that this may be a very temporary fix.

RECOMMENDED CORRECTION OR REPAIRS: Total relocation of the road to higher ground would seem to be the only reasonable solution to this perennial sore spot.

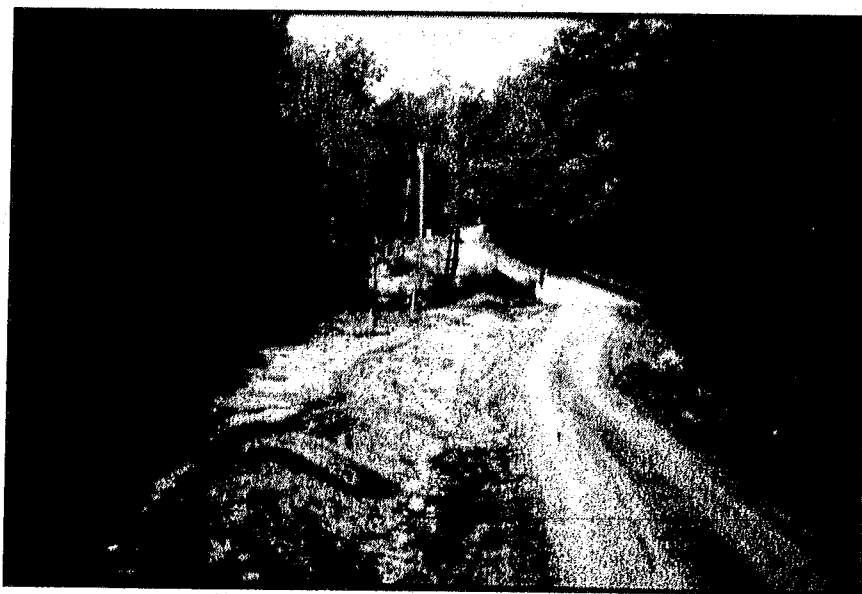
Mile Post 1.6 - Bay Minette Cr. Bridge

Grades approach this stream crossing from both directions and severe erosion from both the road surface and ditches discharge sediment directly into Bay Minette Creek. Extensive deposits of sediment also cover the flood plain adjacent to the stream. This is the highest impact site on the Bromley Road.

RECOMMENDED CORRECTION OR REPAIRS: The first two miles should be a high priority for reconstruction and paving with equal attention to be paid to stabilizing the ditches. This would serve the community of Bromley well and cure the most severe environmental problems. Also, the last mile of dirt road on the east end would benefit from paving. This is a classic example of past weaknesses in the County subdivision regulations which permitted developers to subdivide land without upgrading the road system to meet the needs of the added use. Ditch stabilization and possibly limestone surface is recommended for the intervening 3.6 miles.

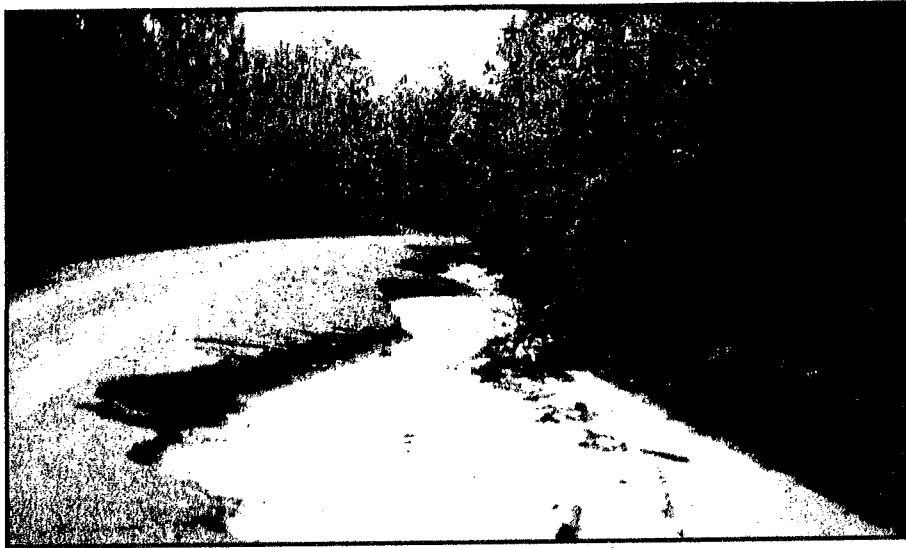
Mile Post 3.7 - Ditch Erosion

Extreme ditch erosion occurs along 0.1 mile at this location. Eroded material is moving out into what appears to be the head of an intermittent stream.

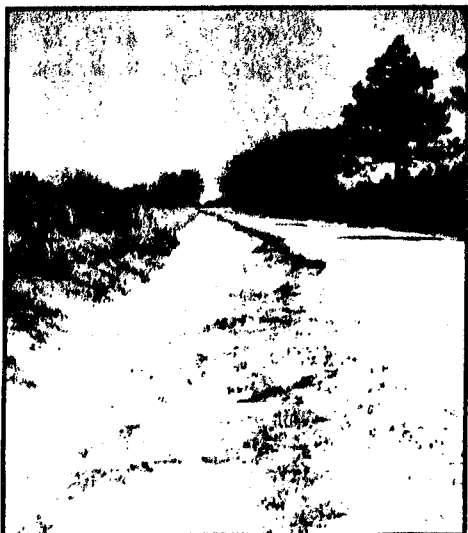
Heavy ditch and surface erosion.

Contributing to the problem is the very severe ditch erosion that takes place along the 0.6 miles of road to the north. Although the roadway surface was stabilized with crushed limestone, the ditches continued to erode so heavily that it undercut the gravel and took the treated surface with it. In some areas the road shoulder was completely destroyed and the surface reduced to one lane. As a result drainage ceased to function and the roadway was breached. All this material has been deposited directly into Palmetto Cr. and its flood plain.

RECOMMENDED CORRECTION OR REPAIRS: Paving the remaining dirt section of John Bloch Road will certainly help, however, the ditches leading to Palmetto Cr. should be stabilized as well. They are the major contributor to the problem. The ditch cross section should be widened and the side slopes and bottom stabilized with rock or turf. Maintenance practices also need to be altered to prevent blading out any stabilization material.

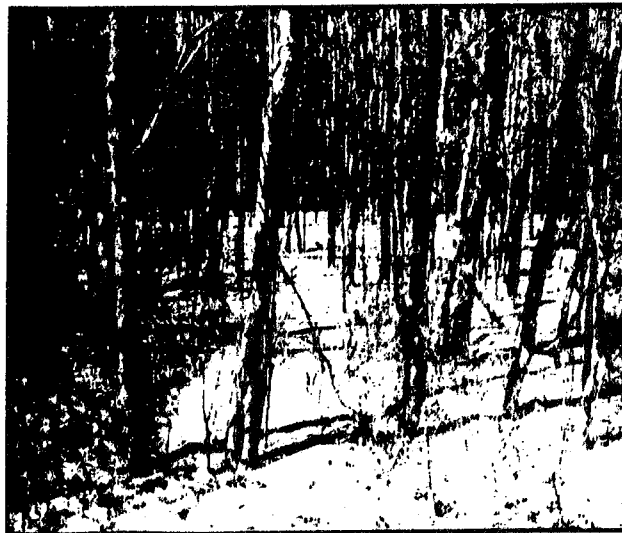
The crossing of Palmetto Cr. has been a problem area for years. Culverts have repeatedly failed and the crossing reverted to a ford for several years. Recently a new culvert was installed and the roadway over it was paved in an attempt to stabilize it. Even so, the road was still breached on the north side of the culvert.

Eroded material fills Palmetto Cr. flood plain.

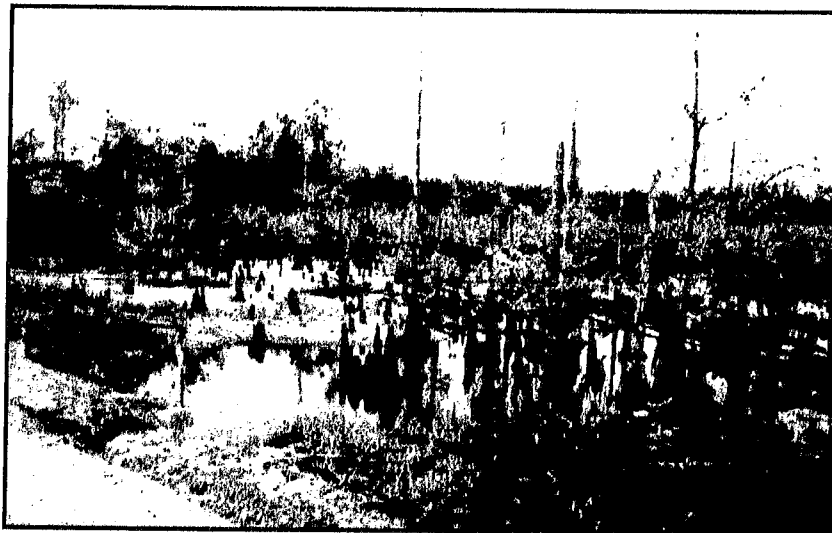
Mile Post 0.25 - Crossing of a fork of Brushy Creek

This is a typical stream crossing along dirt roads in the County. It has been heavily impacted by erosion from the road and its drainage. Although the topography is relatively gentle in this area, the stream shows signs of frequent flooding which is probably the cause of most of the erosion from the road.

RECOMMENDED CORRECTION OR REPAIRS: Stabilizing the road by the most cost effective means would certainly help, however, most attention needs to be directed to stabilizing drainage, Because of the more gentle topography wider, flatter ditches stabilized with vegetation may be the most effective.
